Atmospheric Exposure Tests of Nailed Sheet-Metal Building Materials

Building Materials and Structures Report 128

Theodore H. Orem

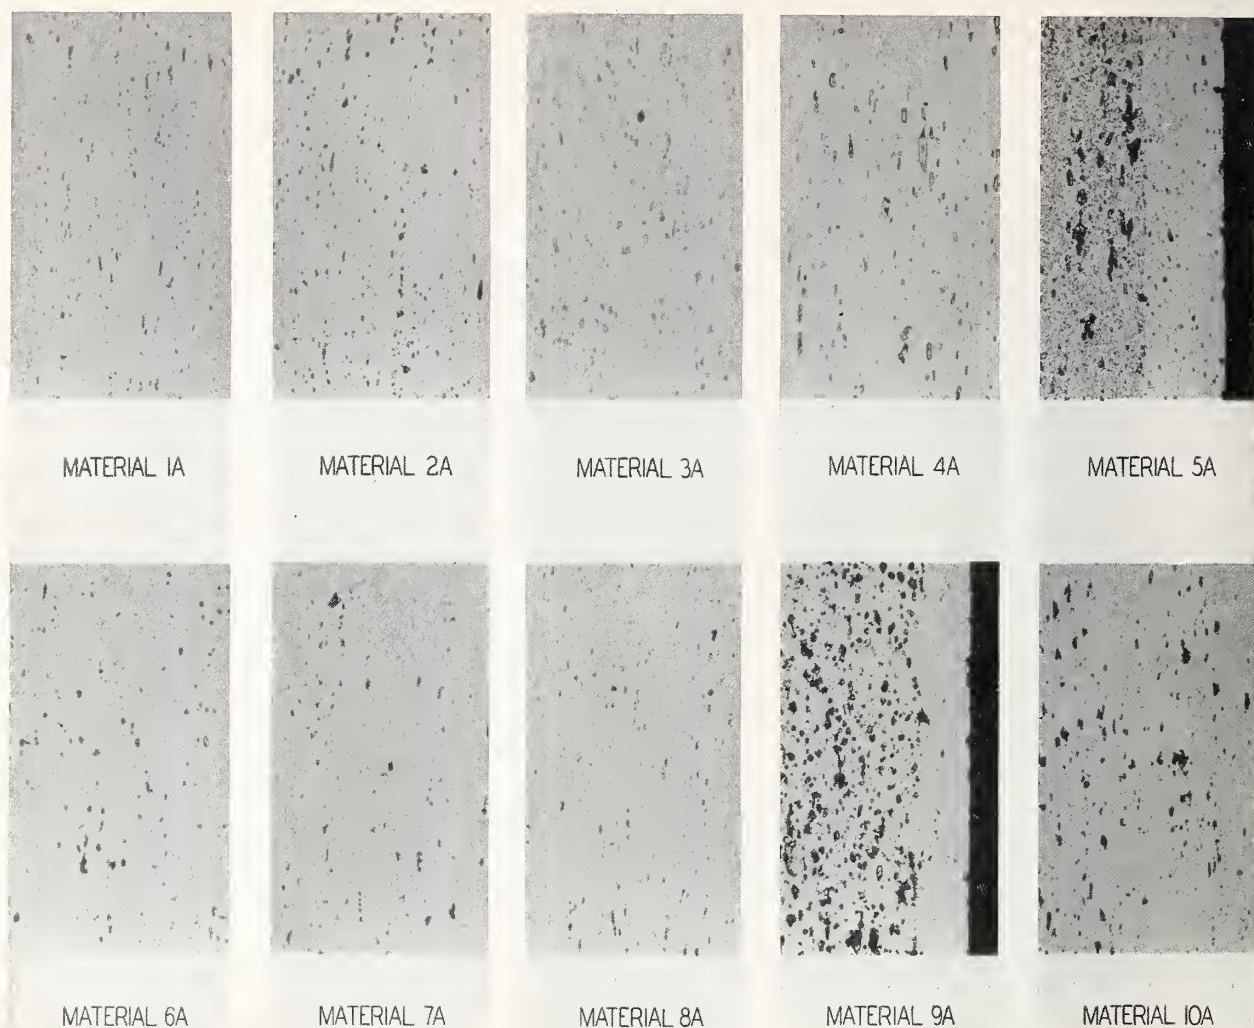
FIGURE 1. Microstructure of aluminum base alloys.

Materials 5A and 9A etched with Keller's etch; others unetched. Photomicrographs in rolling direction at $\times 250$.

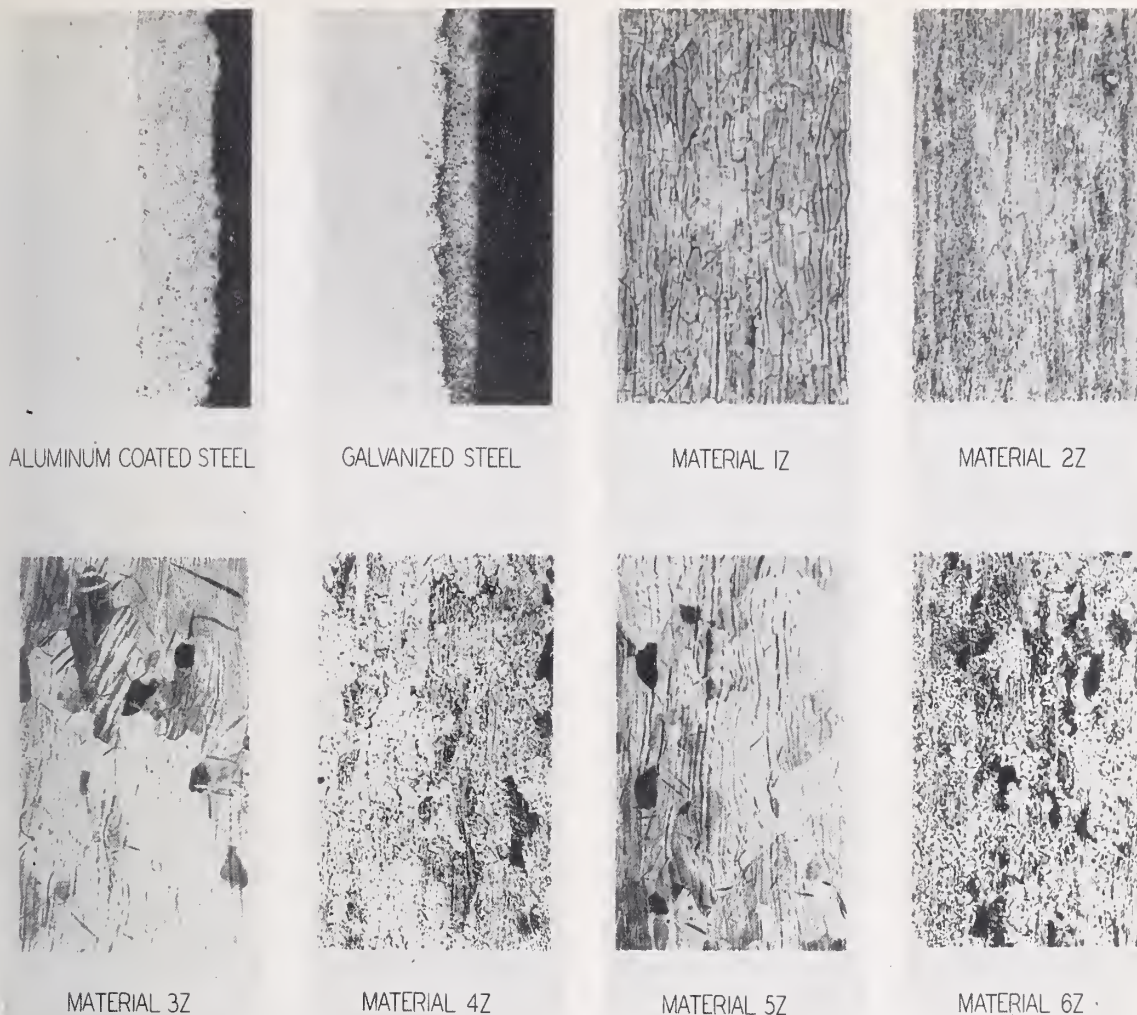
FIGURE 2. Microstructures of aluminum-coated steel, galvanized steel and zinc base alloys.

Zinc alloys etched with solution of chromic acid and sodium sulfate; aluminum-coated steel and galvanized steel unetched. Photographs in rolling direction at $\times 250$.

oz/ft²) were investigated. Photomicrographs of these two materials and the zinc-alloy sheets are shown in figure 2.
